# North Fork Siuslaw Sediment & Habitat Assessment

Final Draft - 2008

Prepared by Demeter Design

Prepared for the Siuslaw Watershed Council

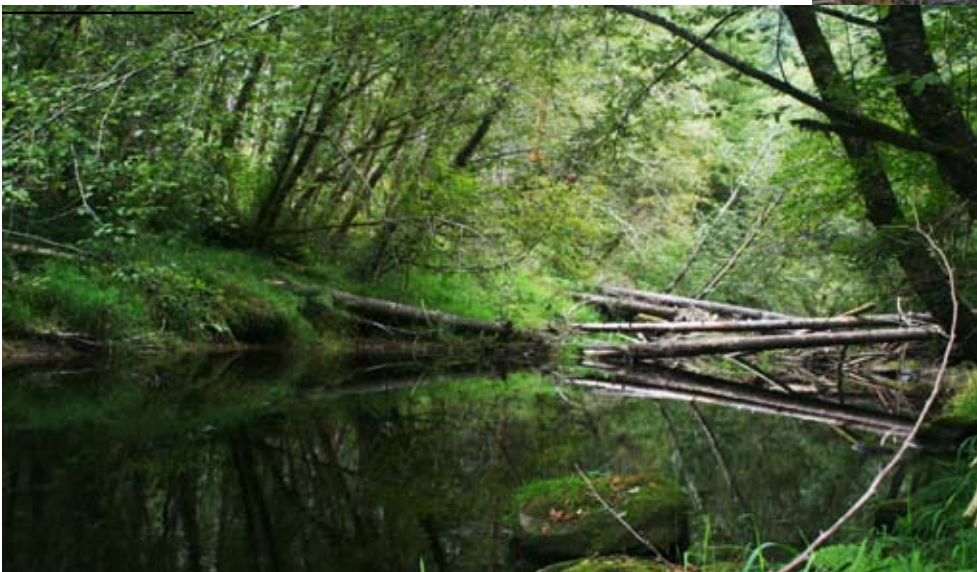
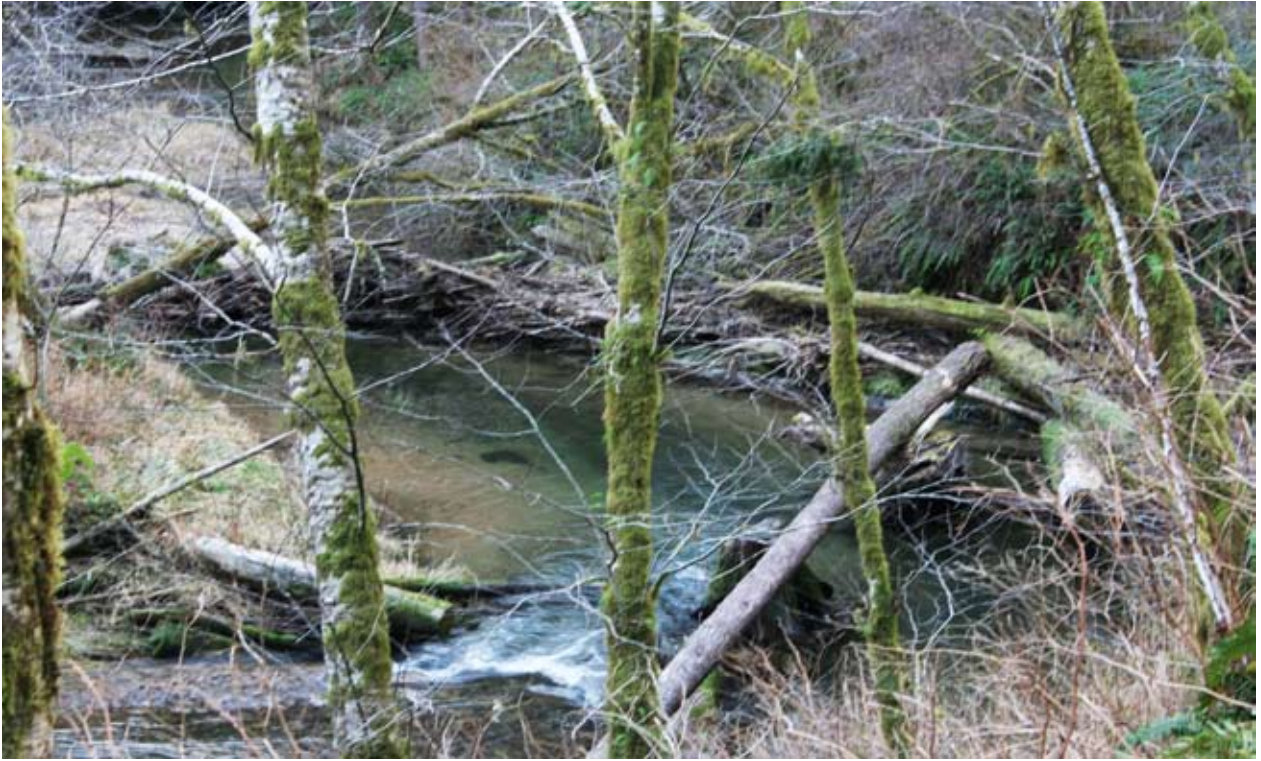
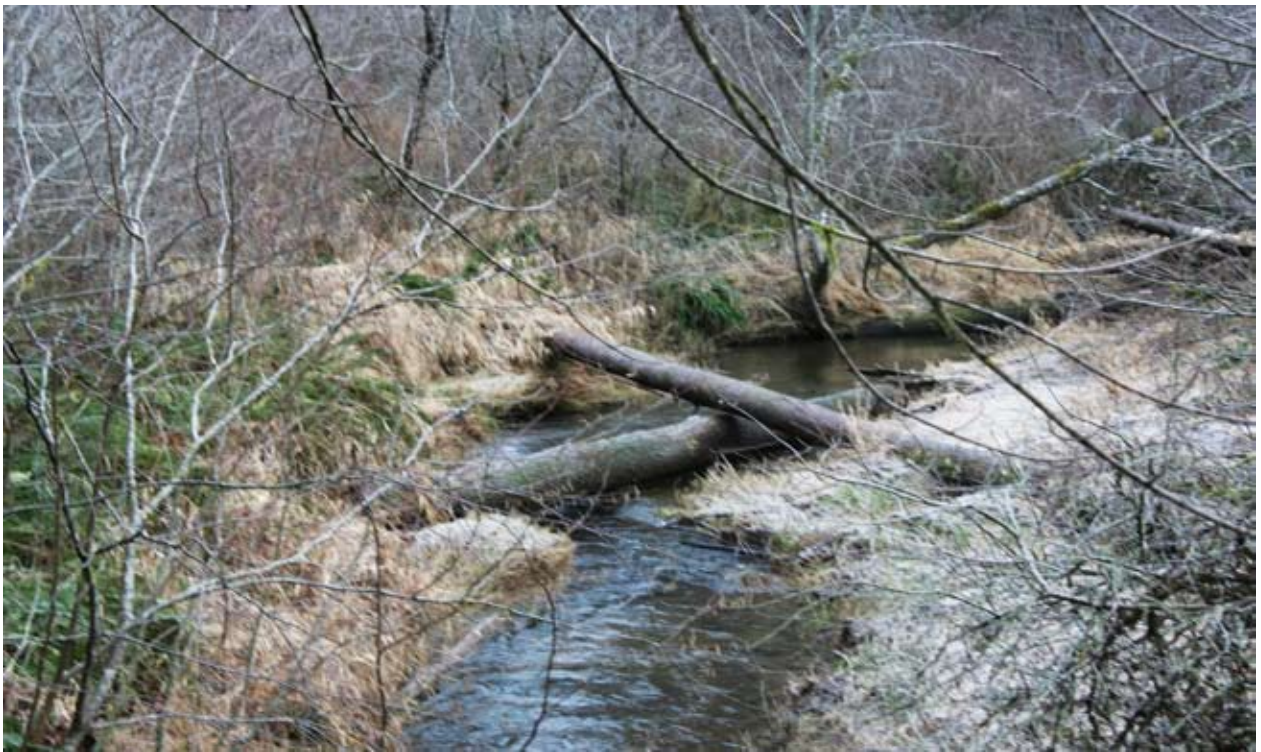
The following four pictures were taken in the NFS basin on USFS land and are examples of some of the restoration activity in the watershed. While many of the log structures observed were providing key habitat components such as refuge from predators and potential overwintering shelter during high flow events, it appears that no log placements occurred in headwater channels. The high average gradient in headwater channels prevents effective sediment storage without the presence of large wood and/or boulders. The lack of large wood due to the Umpqua fire, extensive timber harvests, and management induced debris flows has likely disrupted the natural sediment storage capacity of these headwaters.<sup>1</sup> See the map of known restoration projects on page 52, Map 8.

Prior to 1969, excess logging debris was discarded into streams resulting in a stream network choked with wood which blocked fish passage and decreased dissolved oxygen. In the 1970s, an effort was initiated by various agencies to remove debris from the stream network. Although this effort was intended to improve fish habitat, too much debris was removed. The result was stream channel simplification and the loss of critical instream habitat complexity. Subsequent research clearly indicated the importance of LWD in developing and maintaining healthy aquatic habitat conditions<sup>1</sup>. To correct the situation, the USFS and partners initiated an aggressive effort to replace LWD throughout the stream network. These restoration efforts are still underway. In 2006 the USFS identified a need to plan restoration projects specifically within the NFS.<sup>2</sup> The SWC is an active partner in log placement and riparian planting projects throughout the basin. A map of completed restoration projects can be found on page 52, Map 8. The photographs below are two examples of wood placement in the NFS basin.

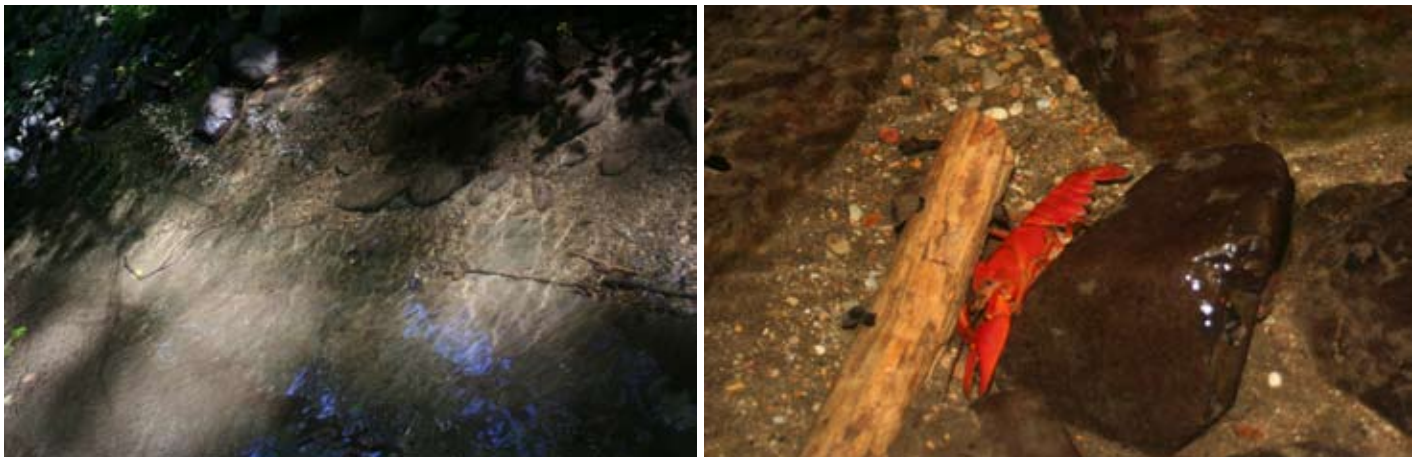
The Relative Bed Stability (RBS) metric was developed specifically to address the effects of bedded sediments on wadeable stream channels. RBS is defined as the ratio of the observed mean substrate diameter to the predicted competence of the channel at bankfull. Channel competence is calculated from field measurements of slope, hydraulic radius, and channel roughness. RBS is a unitless ratio of values, and is commonly expressed as log RBS or LRBS to compress the values and to normalize the variance. When the observed mean particle diameter is equal to the predicted diameter of the largest particle the system can move at bankfull ( $D_{CBF}$ ), the RBS ratio is equal to 1 and LRBS is equal to 0. The observed mean particle diameter and the  $D_{CBF}$  are primarily dependent on disturbance regimes, channel morphology, geology, and climate. For example, small channels with low gradients are expected to have a small mean particle diameter and are not expected to have enough stream power to move larger particles during a bankfull event. The expected RBS score in these circumstances would be similar to a channel with large sediments and steep gradients. In other words, RBS controls for stream power at a coarse level. By logging the RBS value, the data is normalized so that parametric statistical methods can be applied. Previous studies have shown that increases in sediment input result in a fining of the streambed by overwhelming the capacity of the water column to move sediments. Decreases in the RBS score are often correlated with an increased sediment supply. Therefore RBS is a useful measure of current sediment input as well as instream conditions. Extremely low values indicate over-sedimentation (an example would be -2) whereas large values indicate armoring of the stream bed (an extreme example would be +2.) However, this is not always the case. For instance some systems have naturally high RBS scores. Within the Mid-Atlantic highlands, RBS scores are commonly greater than 0. In the coastal reference data, a few sites had LRBS scores between -1 and -3. Evaluation of the system as a whole, including past disturbances, is necessary in order to understand the significance of the LRBS score. An additional strength of RBS is that it is a composite metric calculated from numerous independent observations. This significantly increases the signal to noise ratio and reduces interobserver bias. One caveat to using the RBS metric is that streams can adjust to elevated sediment inputs over long periods of time (e.g. decades) resulting in stable beds that nonetheless contain unnaturally large quantities of fine sediments.<sup>1</sup> RBS is most useful as an indicator of sediment impacts due to current rather than past anthropogenic disturbance. As seen in the photographs below the substrate can be dominated by large gravels, cobbles, or bedrock while still exhibiting poor sorting or being embedded with fine sands. These photographs were taken at two first order streams in the NFS.

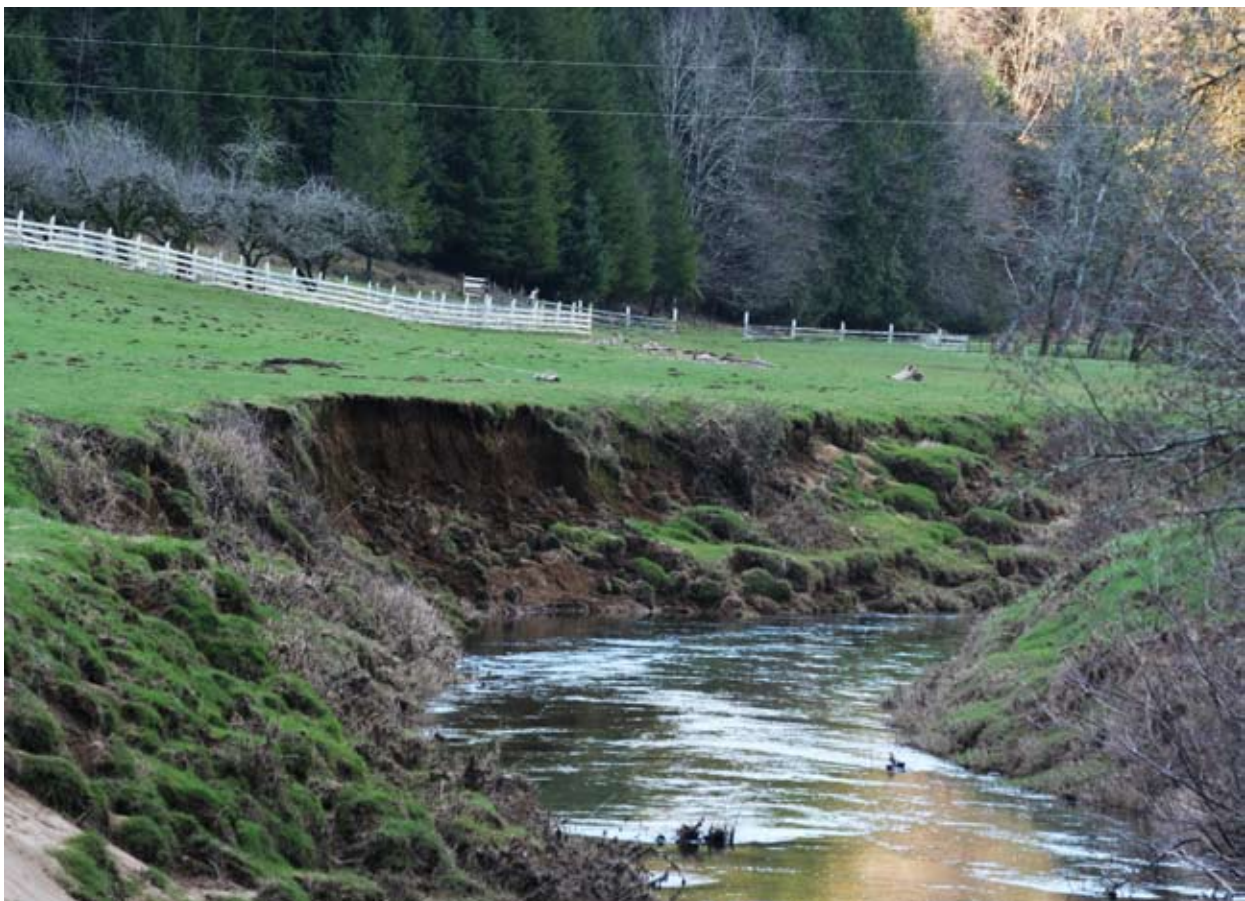
Bank Condition was scored on a scale from 1 to 5 and evaluated in several ways. The average bank condition for the watershed was 1.29. It was greater in the second order streams at 1.45 vs. 1.25 in the first order streams. Within the second order streams, bank condition scores were primarily driven by the presence of a road that ran along the entire length of the NFS mainstem. Rip rap often prevented any erosion in addition to limiting natural channel migration. Confinement by road proximity is decreasing the natural sinuosity of the NFS mainstem and is also increasing channel competence. Bank condition was also calculated by scoring banks with no disturbance as 0 and averaging all scores greater than 0. The result of this analysis indicated that 4 sites appeared to have no disturbance on any transect whereas 18 sites had at least one bank per transect with active erosion ranging on a scale from 2-5. Additionally sites were classified as either an “A” for no human presence or a “B” for human presence. All second order sites and two first order sites were listed as “B” sites and 12 first order sites were listed as “A” sites. No sites visited had banks actively affected by cattle grazing. This practice appeared to be more prevalent lower on the NFS mainstem where the river became unwadeable. The lower portion of the NFS was photo-documented in order to capture this missing information. The photograph shown below is an example of the bank condition on the unwadeable NFS mainstem. Additional photographic data is available upon request from Demeter Design and the Siuslaw Watershed Council.

Sites 6, 16, 24 are dominated by bedrock outcropping which are always ranked as a one

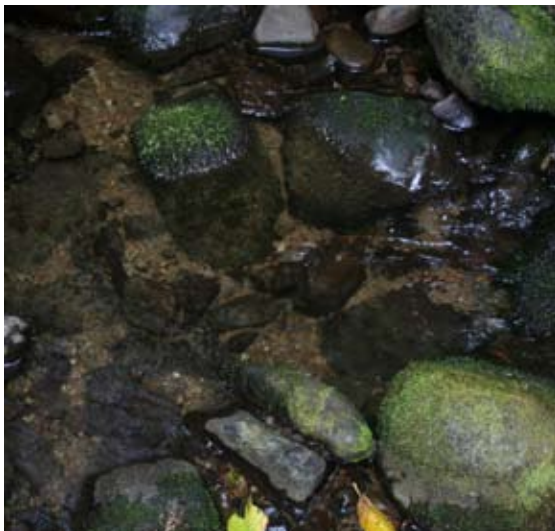
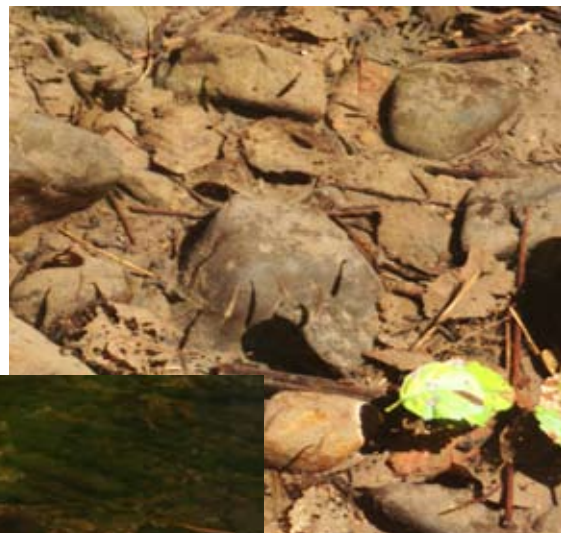
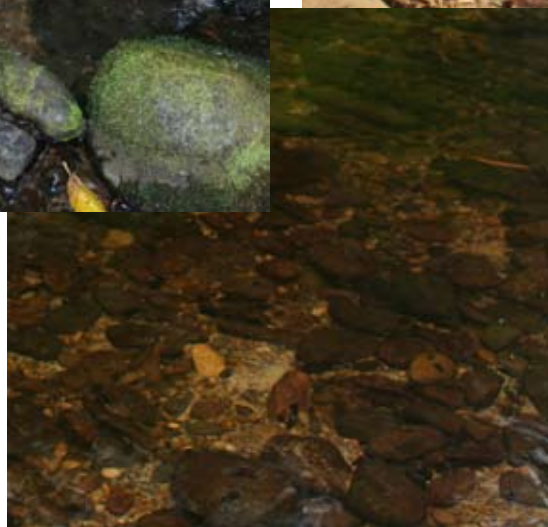
While the quality of physical habitat was generally lower throughout the mainstem, a greater quantity and proportion of the first order streams exceeded the 25th percentile for %SAFN. Despite this result, field observations suggest that the substrate within most first order streams was better sorted than second order streams. High levels of embeddedness were observed throughout the mainstem, and in some places there was a layer of sand on top of bed rock from 1-100+ cm thick. This is illustrated in the photos below. What was most striking was the location of sands. Although %SAFN within the NFS greatly exceeded the average for the coastal reference data, the RBS scores indicated significant armoring in the second order streams. RBS scores for the tributaries are similar to reference conditions but the amount of wood is low relative to reference and W:D is elevated. As previously mentioned lack of LWD increases stream competence and disrupts natural sediment sorting processes.

Embeddedness was observed throughout the study area. Photographs on page 59 are examples of the embeddedness within the NFS watershed. Increased LWD recruitment into headwaters will reduce fine sediment inputs. Novel silvicultural treatments and wood placement strategies may be needed to meet this goal. As wood volume increases in transport and depositional reaches, the increase in hydraulic roughness is expected to lead to increases in fine sediment accumulation. Restoration efforts within these transport and depositional reaches should proceed concurrently in the upper watershed in anticipation of this expected effect.

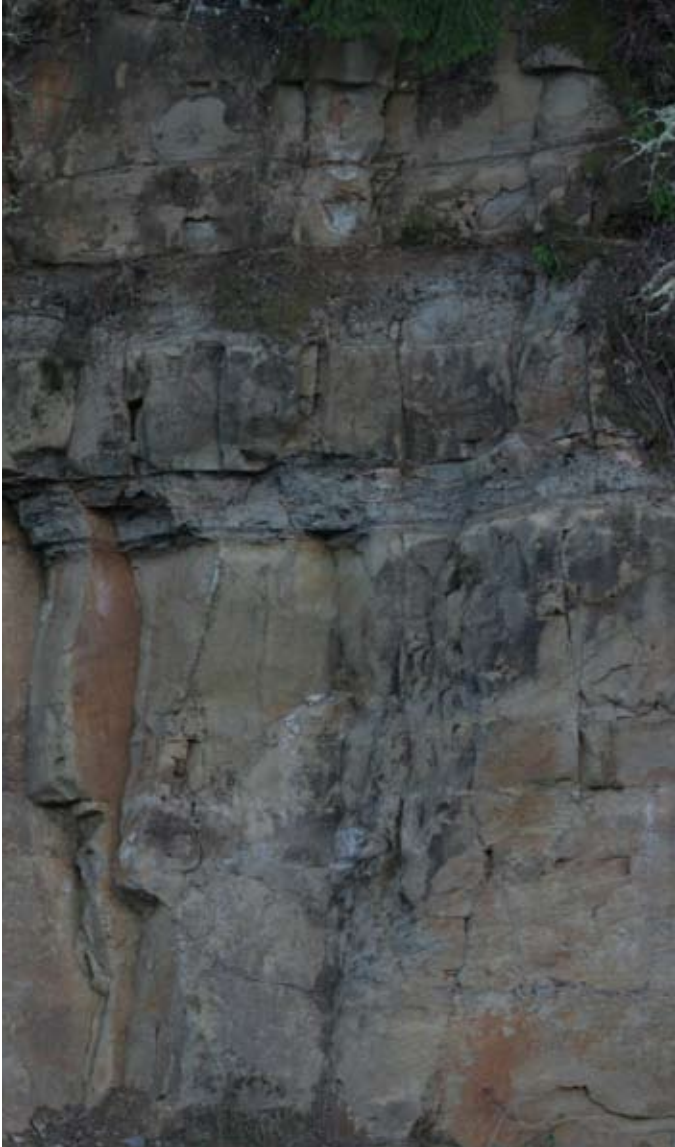
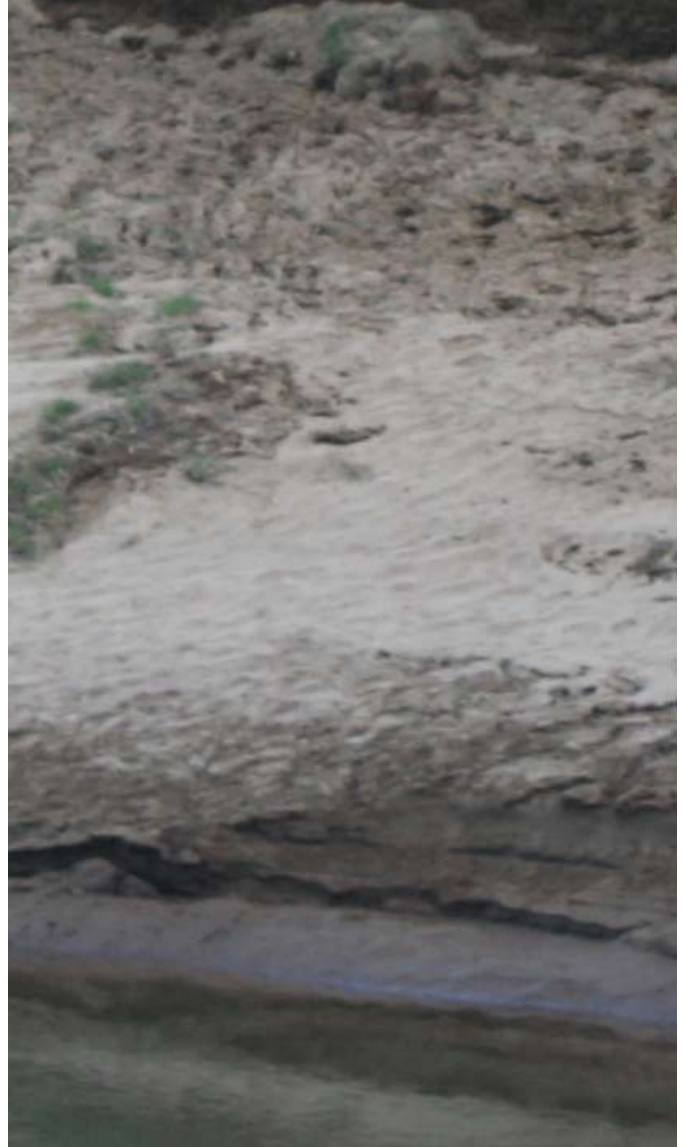
## Bank Condition Assessment

Bank condition was assessed visually by classifying active erosion into one of 5 categories; on a scale of one to five with one representing no active erosion and 5 representing complete active erosion. At each transect, both the left and the right banks were classified individually using this scale. Bedrock was always scored as a 1A\_2 or 1B\_2 and landslides were always scored as a 5A or 5B. This guide depicts photographic representations of 1, 2, 3, 4, and 5 type banks. Additionally, banks can also be classed as either an A or B where A represents sites with minimal human presence and B represents human activity on the bank. Human presence is defined as the presence of a road, agriculture, a dwelling, recreation, or non-native vegetation.

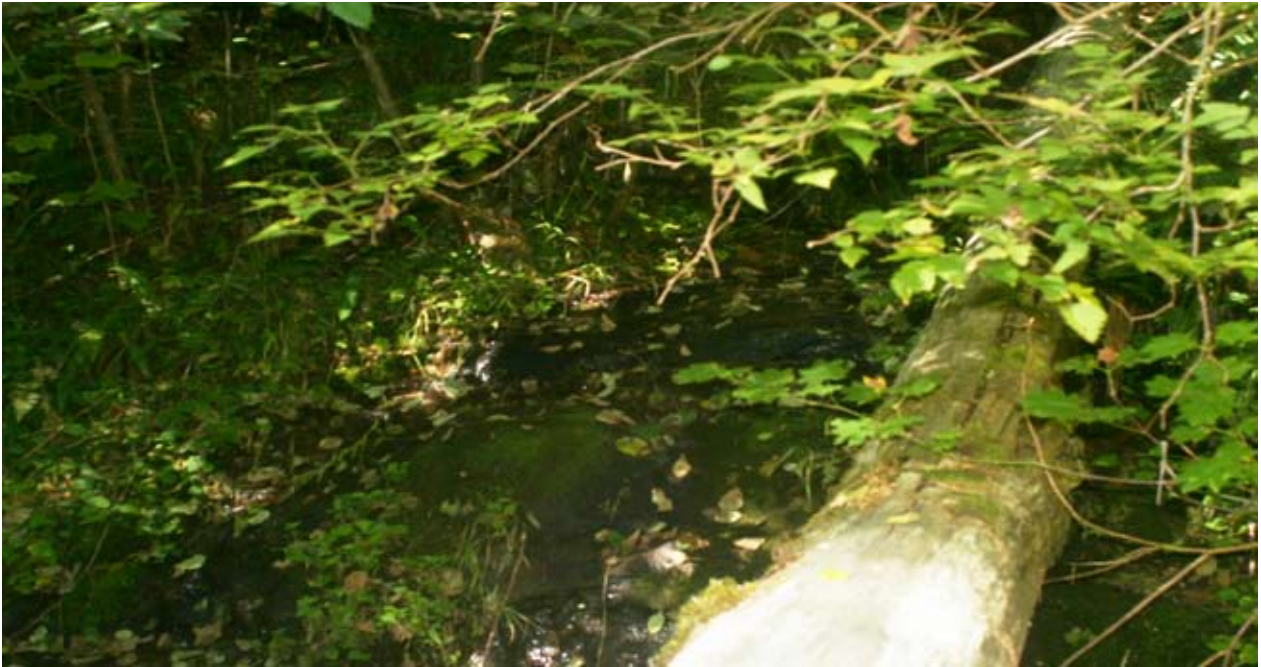
This is an example of a 1A\_2. At this point, there is no sign of active erosion or human presence but the stability is driven by the bedrock outcropping. This photograph was taken in the NFS.

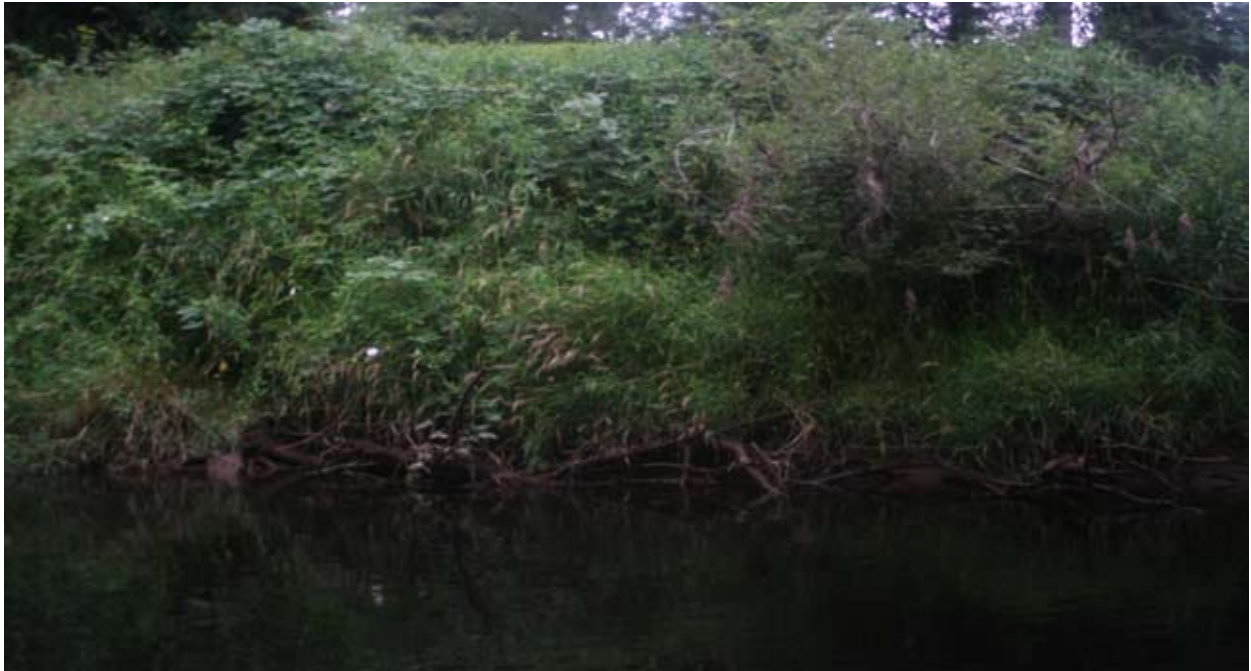
This is an example of a 1B. At this point, there is no sign of active erosion but strong human presence, Himalayan Blackberries and Reed Canary Grass on the bank of a private residence. This photograph was taken in the NFS.

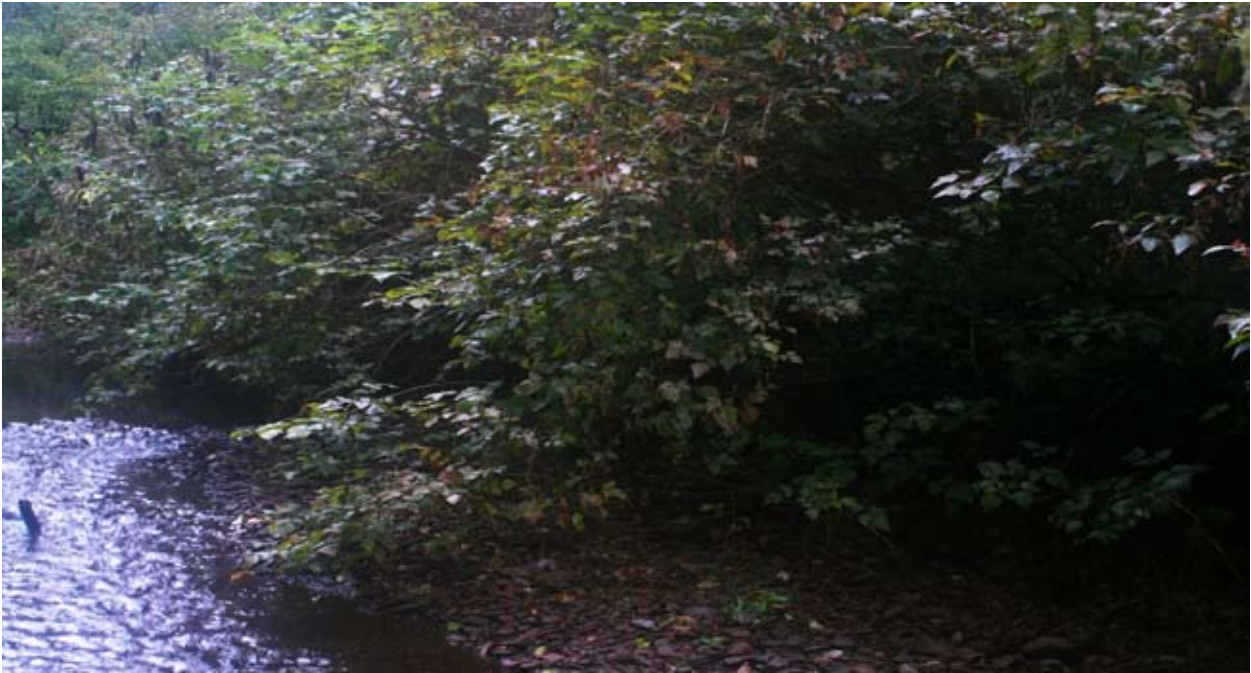
This is an example of a 2A. At this point, there is little sign of active erosion and no human presence. While not visible in this photograph, the erosion is occurring behind the overhanging vegetation. This photograph was taken in the NFS.

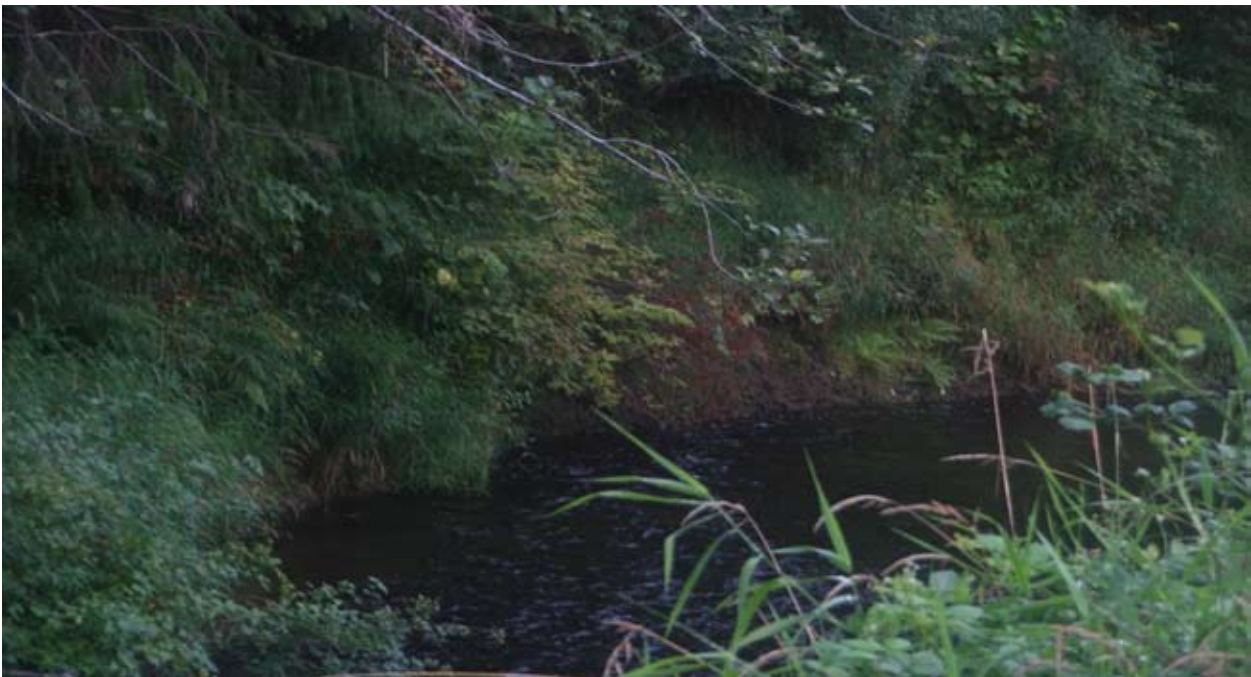
This is an example of a 2B. At this point, there is little sign of active erosion with human presence with Reed Canary Grass on the bank of an unused pasture. This photograph was taken in the NFS.

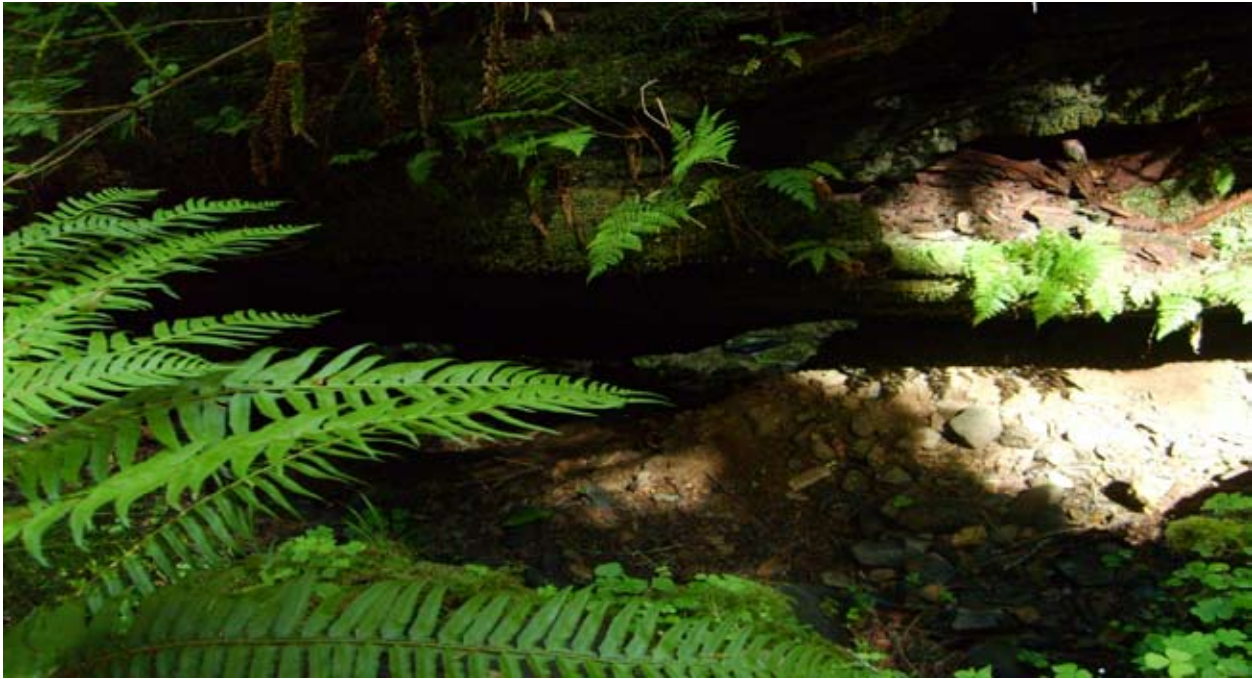
This is an example of a 3A. At this point, there is clear evidence of active erosion and no human presence. This photograph was taken in the Wilson River Basin in Tillamook Oregon.

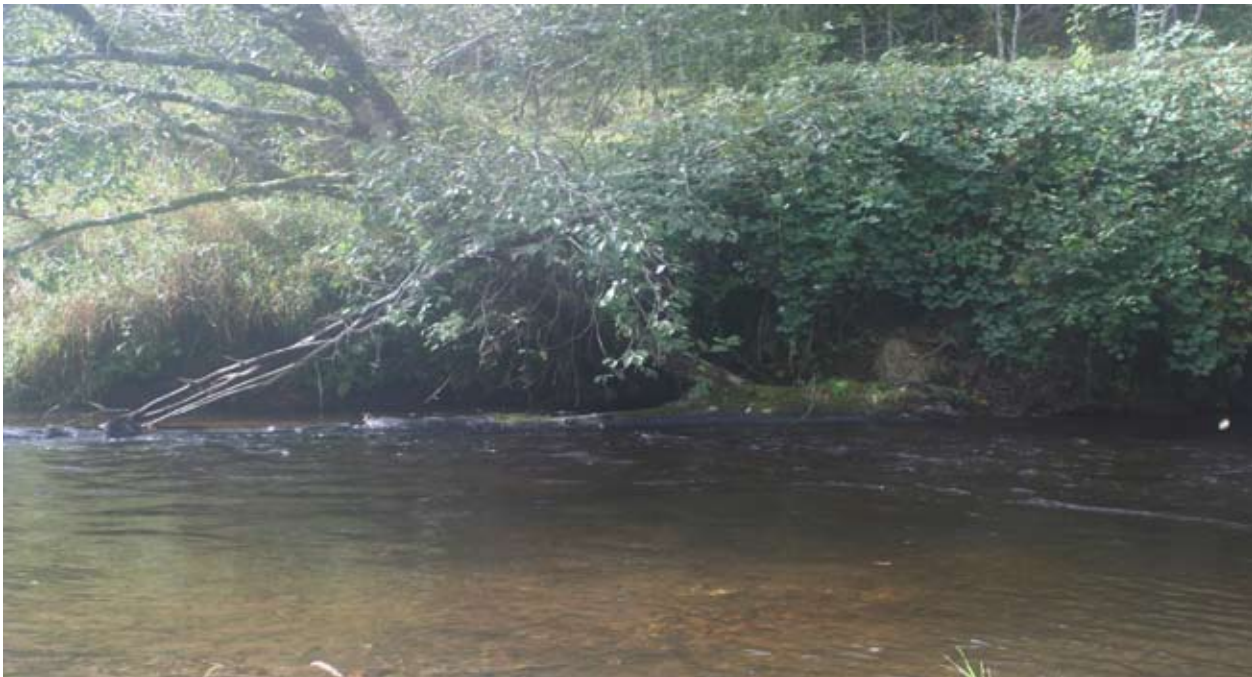
This is an example of a 3B. At this point, there is clear evidence of active erosion with human presence. While not visible in this photograph, the erosion is occurring behind the overhanging Himalayan Blackberry. This photograph was taken in the NFS.

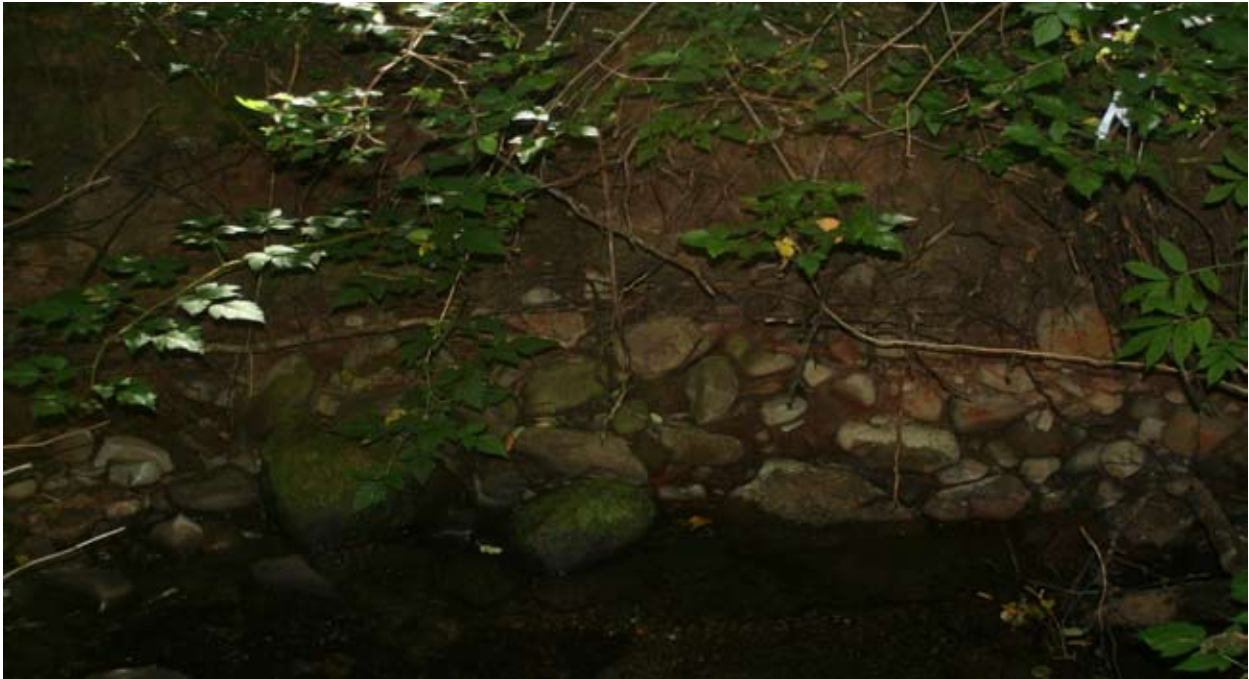
This is an example of a 4A. At this point, active erosion is nearly taking place on the entire bank. There is little vegetation and the presence of Salmon Berry which correlates strongly with disturbance. There is no human presence. This photograph was taken in the NFS.

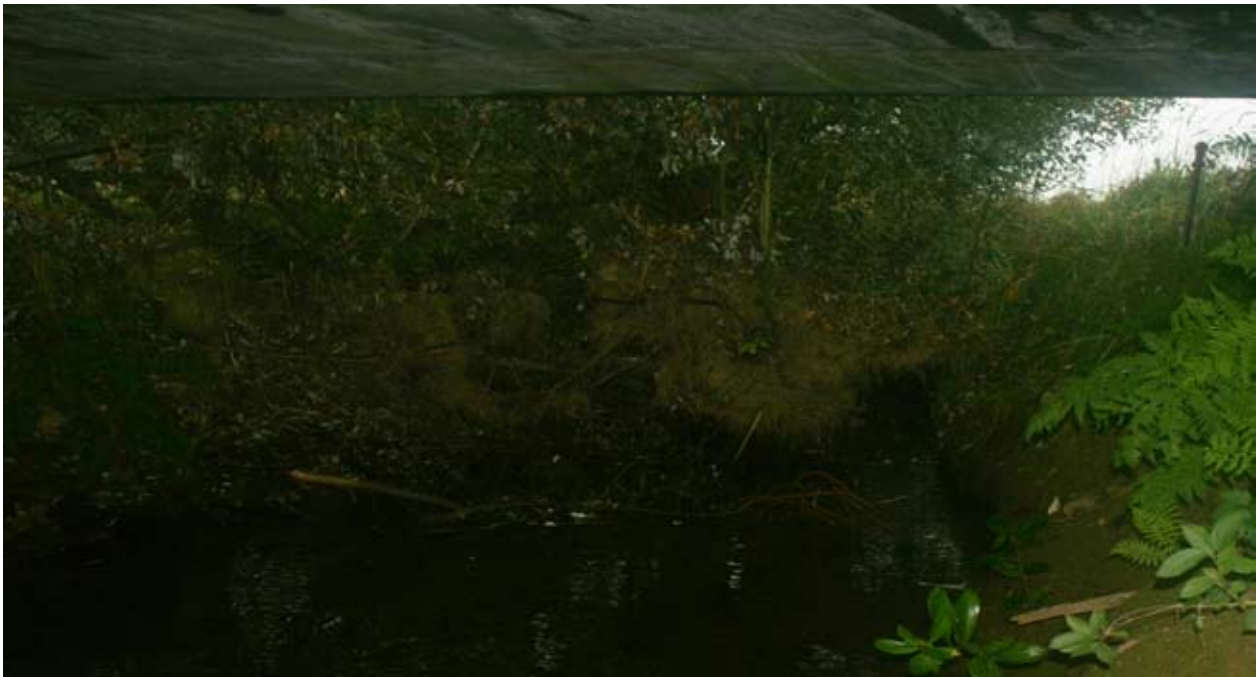
This is an example of a 4B. At this point, active erosion is nearly 100% of the bank with human presence. This photograph was taken next to a bridge in the Tillamook River basin in Tillamook Oregon.

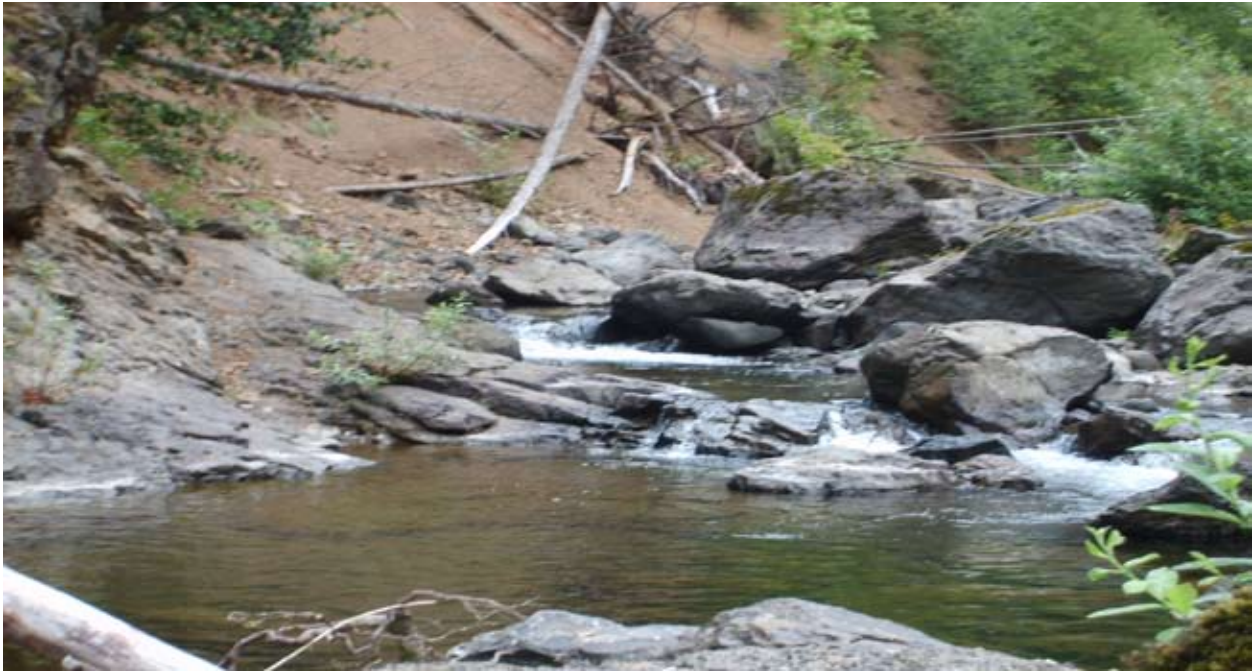
This is an example of a 5A. At this point, there active erosion is complete with minimal human presence. It is important to note that 5A sites are much less common than 5B sites. This channel was a confined bedrock chute along HWY 6. The road is greater than 30 vertical meters from the channel but less than 30 horizontal meters away. This landslide is not directly caused by the presence of a road. This photograph was taken in the Wilson River Basin in Tillamook, Oregon.

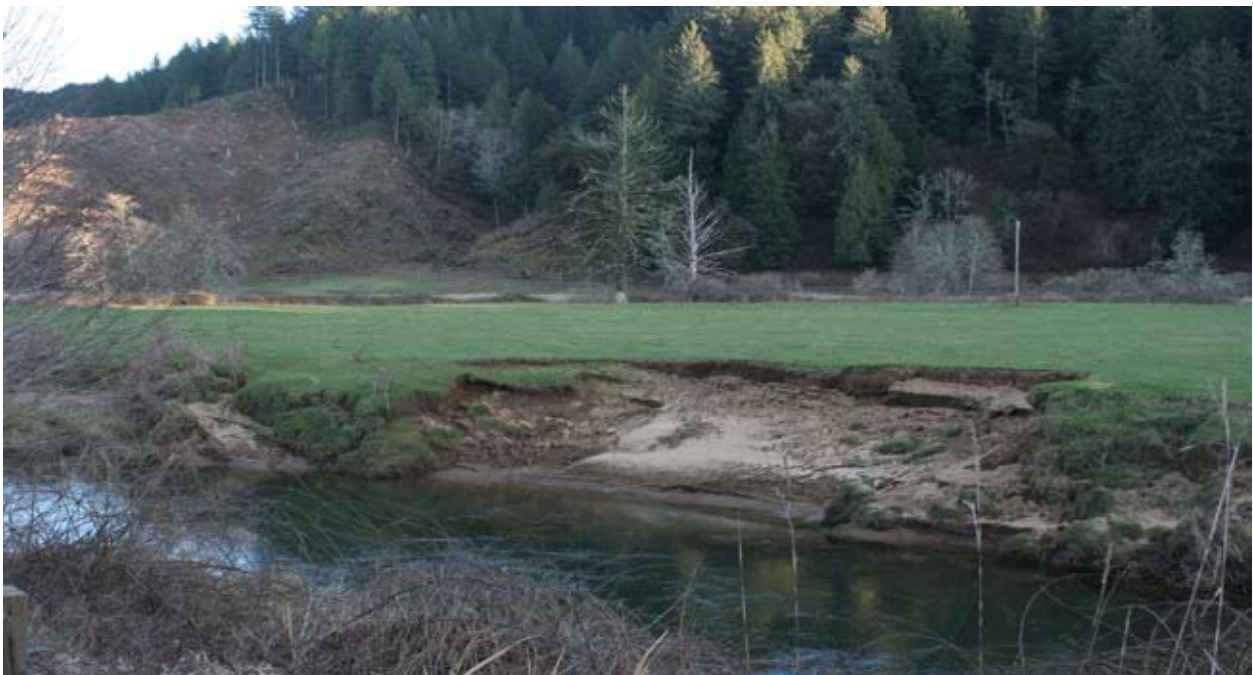
This is an example of a 5B. At this point, active erosion is complete with human presence. This pasture was being actively grazed at the time this photograph was taken. There was no clear cattle exclusion. This photograph was taken in the NFS.
