The Netarts Bay Watershed

Habitat Study, Restoration Plan, and Limiting Factors Analysis

Prepared by Demeter Design, 2008

Demeter Design, 2008
Prepared for the Tillamook Estuaries Partnership

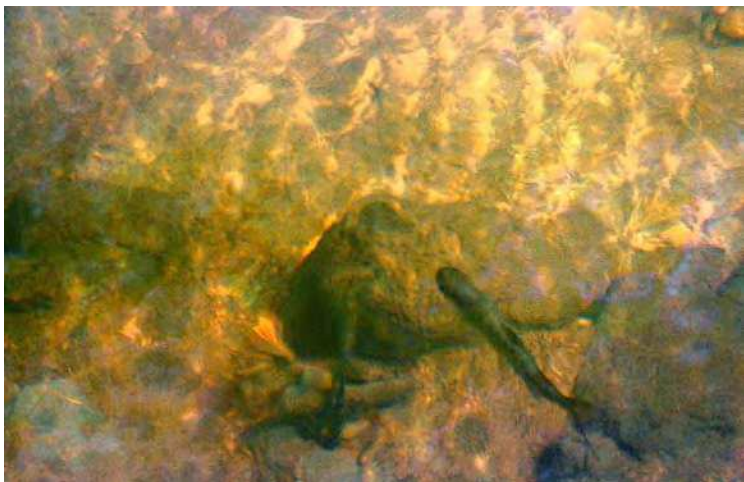
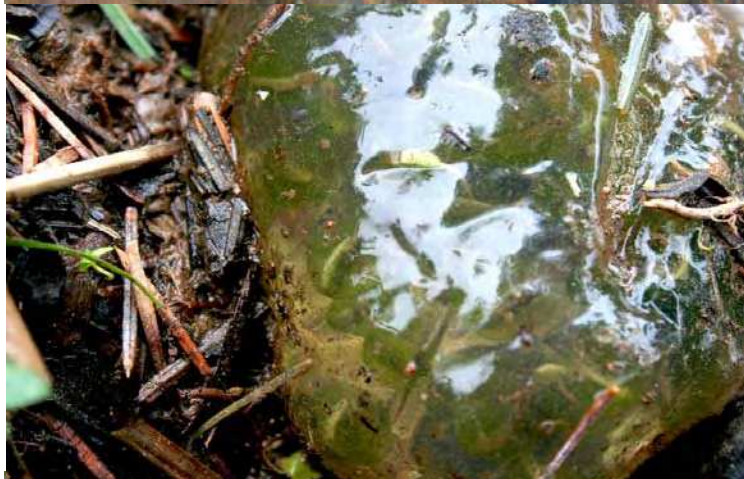
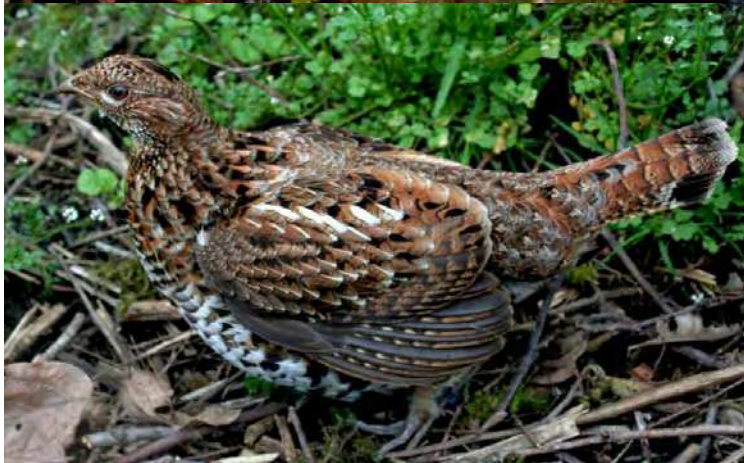
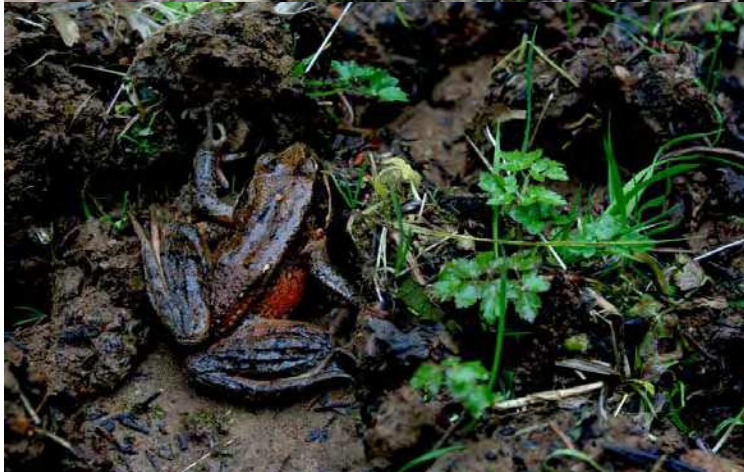
Road crossings and barriers – Only one remnant road crossing occurred on the North Fork of Whiskey Creek and this culvert had been removed. A tarp blocks a side-channel to the Mainstem of Whiskey Creek. During low flow some of the larger beaver dams may block juvenile migration.

Although there were no definitive high risk slopes within the area surveyed, hill-slopes became much more steep past the survey terminus. This region (not a high risk slope area using the RML data; it is possible this layer is too coarse) could provide large wood and gravels were they to fail.

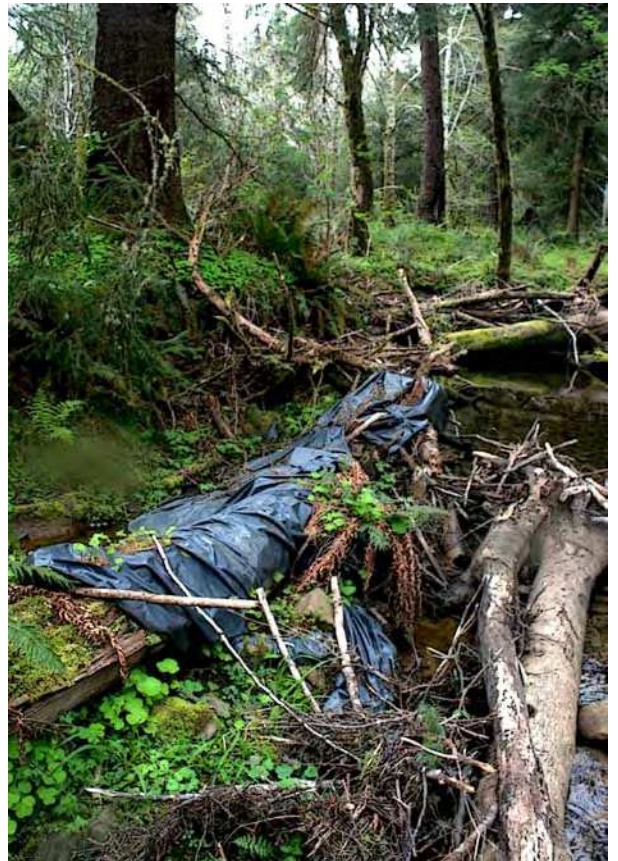
The hatchery dam is a juvenile passage barrier leaving only the North Fork for over-wintering habitat for any juvenile salmonid washed or spawned downstream of it. Additionally, the Hatchery has placed a tarp over the entrance to a side channel to the North Fork (see photograph above). This coupled with the danger of the hatchery intake may limit the ability of juvenile salmonids to access the North Fork to rear. One remnant road crossing occurs on the mainstem although the road had been decommissioned. Additionally, 6 road crossings block wood passage on high risk slopes.

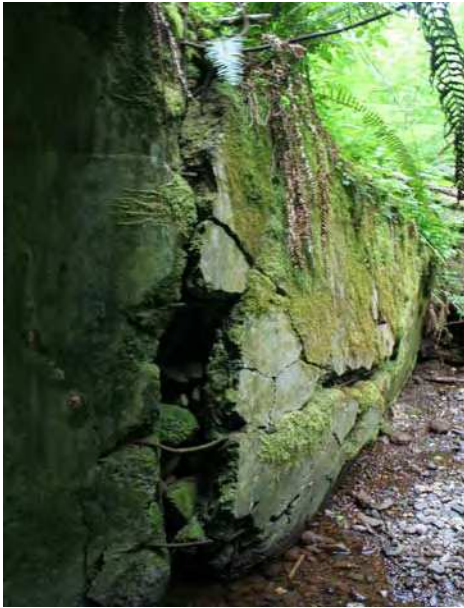
A remnant road crossing in the park (adjacent to a picnic area) serves as a juvenile barrier. The old road grade is essentially a series of concrete blocks that raises the stream bed behind the dam by ~ 1m. The fill behind this dam is predominantly well sorted gravels and cobble. The spawning potential downstream of this juvenile barrier is minimal (it is nearly at the mouth) and does not justify dam removal. The use of this site as a ford should be limited however, riparian planting between the picnic table and the stream would reduce local foot-traffic through potentially good spawning habitat. The park water intake blocks access to a rearing pond created by a beaver. Finally, the fish ladder may not pass juvenile salmonids. The failing retaining wall is displayed in the photograph below.

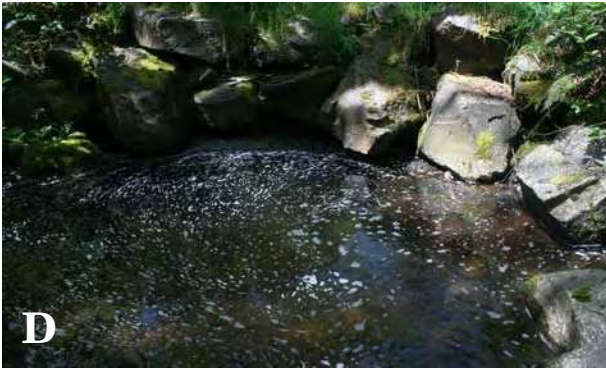
The culvert at the campground road may be partially blocked (see photograph D at left). Fish utilize the pool upstream of this culvert but flow is significantly reduced. Additionally, Bay-going Jackson is flanked on the eastern bank with a historical road which directs high flows away from the Netarts Creek (Jackson Channel 2) and into the campground.

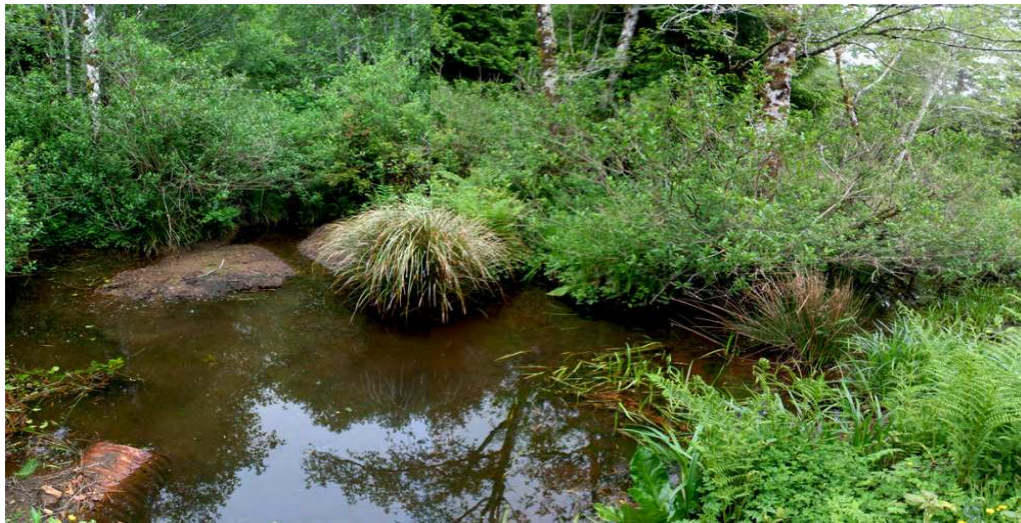
It appears that the headwaters of Netarts Creek (Jackson Channel 2) periodically flow into Jackson Channel 1, which during the 2008 surveys was dry. It appears that the flow which Jackson Channel 1 receives on occasion was diverted by a fallen tree and a landslide. Netarts Creek contains abundant gravels although they are only moderately sorted. An emergent fry was seen in the wetland complex between the campground road and the Netarts – Pacific City Highway. The culvert on Netarts Creek is very undersized at ~.3m diameter with bankful above and below between 1.5 and 3 meters. Additionally, the road drainage ditch upstream of this culvert diverts the majority of the winter flow down the road. This may reduce the summer input of water into critical spawning areas near the campground. The headwaters of Netarts Creek are confined by high risk unstable hill-slopes. This area supplies large quantities of resistant spawning gravels. One emergent fry was seen in a very shallow pool/riffle complex just below the road in this wetland. Additionally, the wetland supports juvenile over-wintering Coho as well. Beaver presence is high and maintains several step-pools over reeds, rushes, and sedges. This area is impacted by an undersized culvert that restricts passage into and out of these beaver ponds but also reduces the capacity of this wetland to recharge the lowest reaches of Bay-going Jackson near the campground (see photograph below).

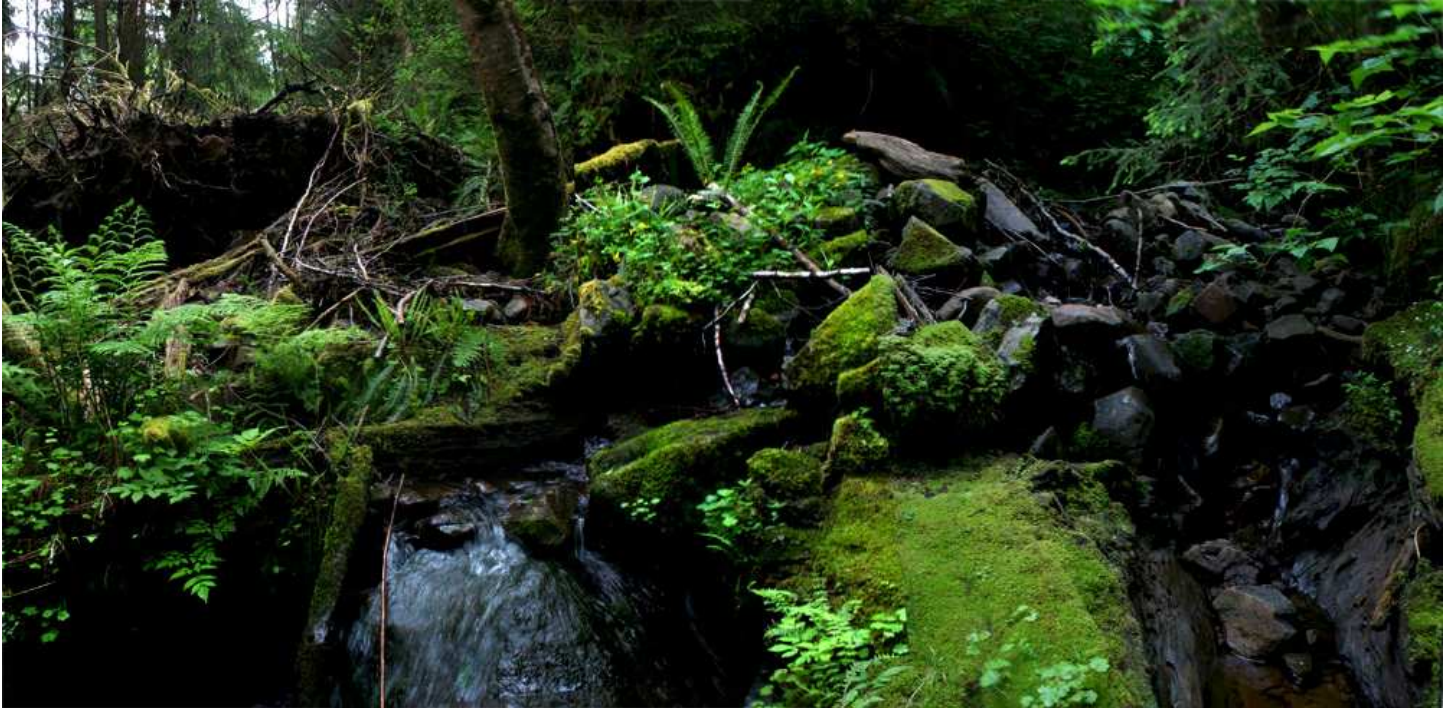
The headwaters of Netarts Creek are dynamic and change channels frequently (See photograph below). There are very few pools and these are of minimal size. Spawning occurs directly upstream of a large freshwater wetland fed by four of Jackson's five creeks. Access to this wetland are likely the limiting factors for both Bay-going Jackson and Netarts Creek, both of which have undersized culverts not passable to juvenile salmonids and possibly adults. Neither stream has abundant pool (winter and summer rearing) habitat outside of this wetland.

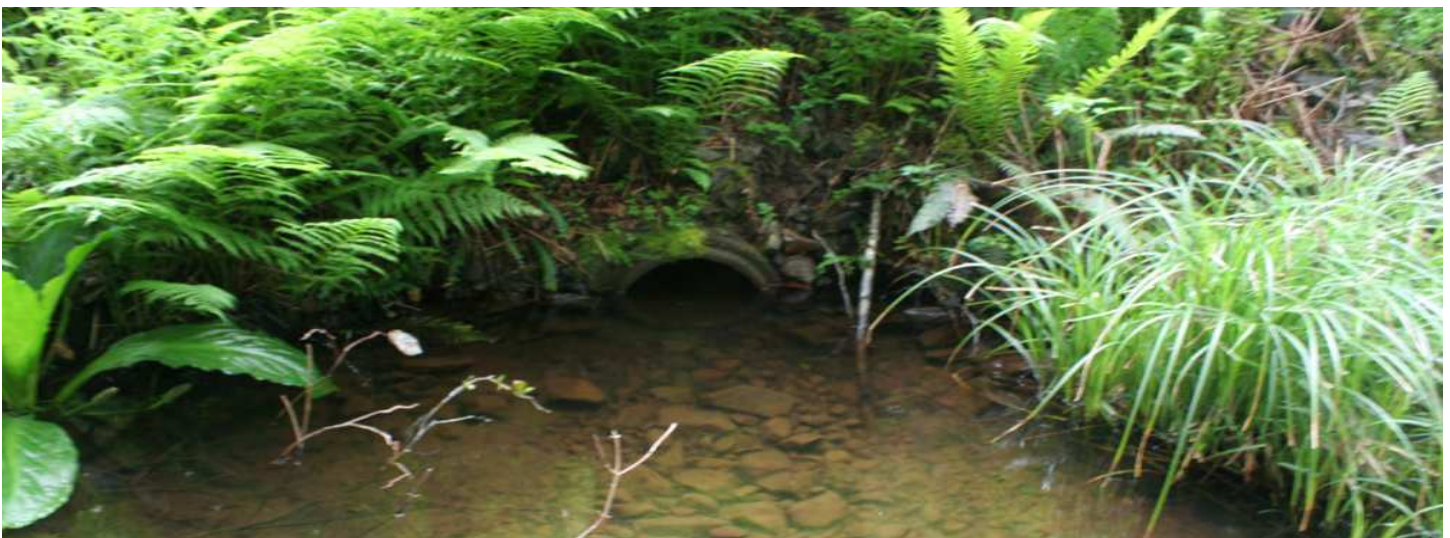
The culvert at Netarts-Pacific City Highway is undersized and impassible and may also be a hazard during flood events (see photograph below). Several work crew members stated that during the most recent flood event they had been called out to clear the blocked culvert and that water had been running over the road. The authors of this report have observed this culvert during high flow events and have noted water flowing adjacent and across the road and into currently-dry portion of the wetland.

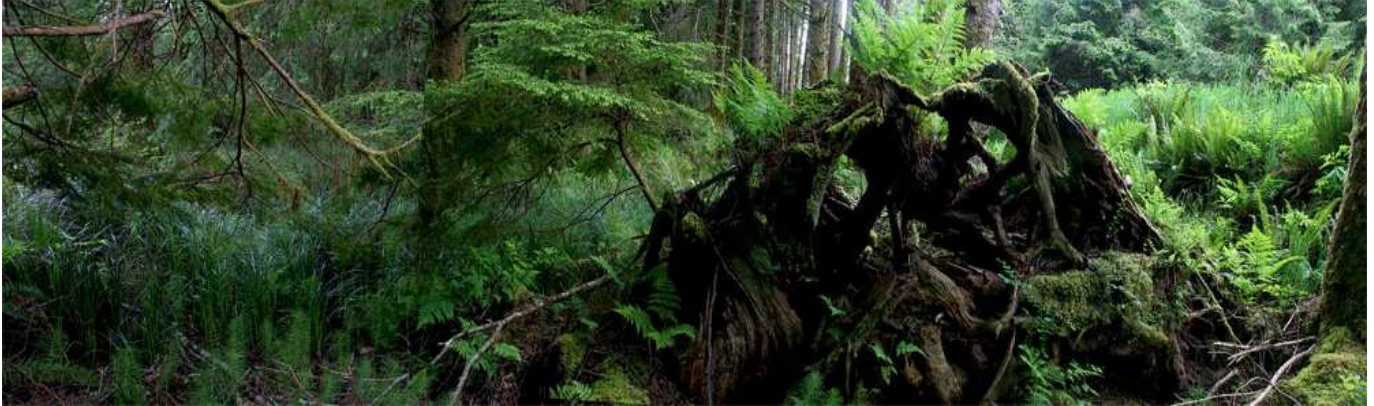
Jackson Channel 1 is a puddle channel. This channel appears to carry water from the road-side drainage ditch and from Short Creek during extremely high flows. Recent scour was not evident and the channels contained salmonberry suggesting that Ch. 1 had not carried much water for a few years. Two culverts had minor flow (see photograph on bottom left).

There are two small culverts perched high above the channel although minimal flow was observed during the field season.

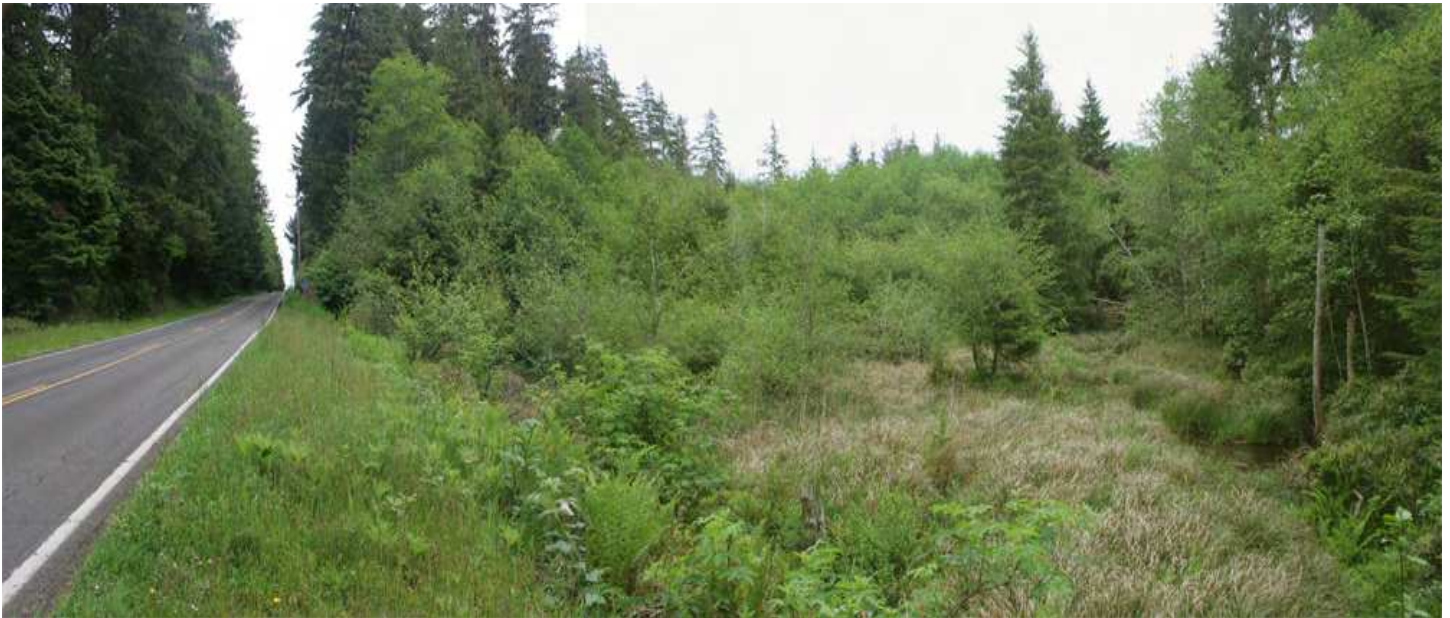
Austin Creek enters the bay through a freshwater wetland. This wetland is likely the result of the road impoundment but it is maintained by beaver activity (see photograph below). The first culvert, although undersized, appears passable to adults and juveniles although it may be a winter juvenile velocity barrier. The entire southern hill-slope along lower Austin Creek had been harvested and replanted within the past three years. The riparian buffer was largely reduced by the most recent windstorm and large volumes of wood had entered into the channels either from topping or more commonly from uprooting. This wood immediately created a great deal of habitat complexity. A remnant road crossing had been recently decommissioned the banks of which had not been replanted (see photograph below). These banks are possibly supplying excess fine sediments which settle in downstream beaver ponds. Measurements of ponded-sediment (predominantly silt) depths were consistent at ~1 meter deep. Resistant substrate and spawning gravels were observed throughout Austin upstream of this. Low volumes of instream wood were observed upstream of the second road crossing. The entire upper-Austin drainage is comprised of a volcanic substrate providing large quantities of gravels to the system although spawning is limited to a very short reach as a result of poor sorting. Spawning reaches are dominated by landslide deposits perhaps explaining the quantities of fine sediments found there.

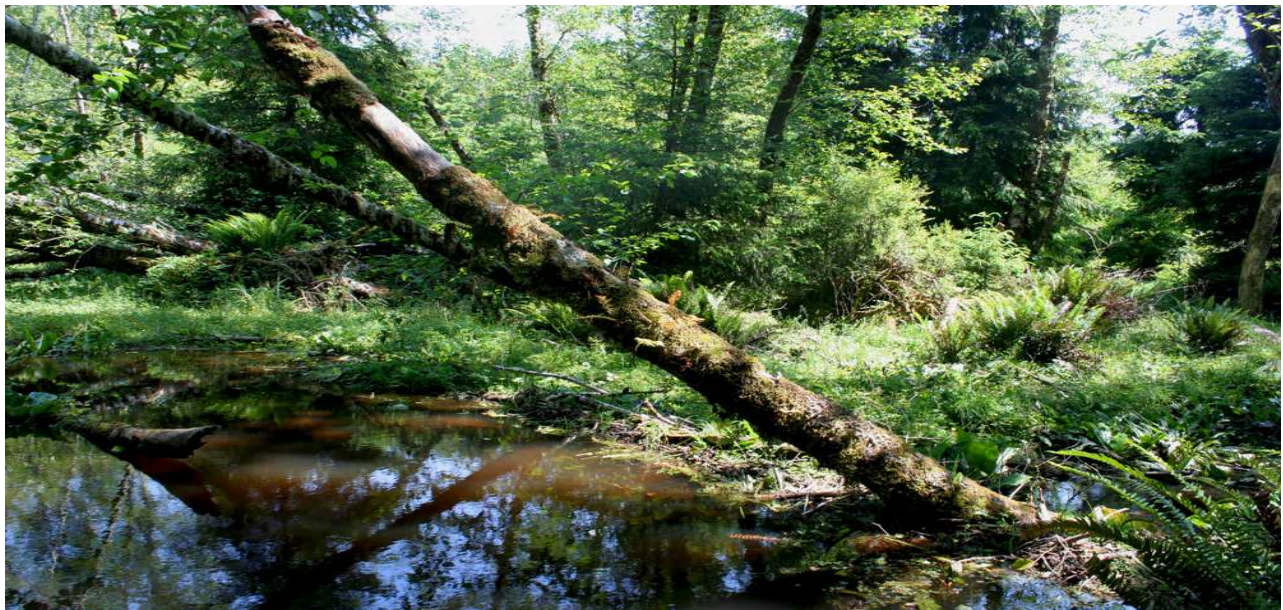
Yeager is dominated by wetland habitat (see photograph below). The lowest ~200 m of stream are tidally influenced marsh. The stream channel surveyed is an unconfined braided channel dominated by a sandstone geology. Unidentified fish were observed in this area. As the stream becomes freshwater beaver activity dominates the landscape. Nearly the entire lower creek is beaver dominated. No spawning gravels were present and no salmonids were observed. Historically lower Yeager was straightened and diked from half of its potential wetland habitat. The south fork of Yeager Creek is blocked to all fish passage by a failed culvert. The road forming the dike is currently protected only by a small beaver dam directly in front of the failed culvert which filters all debris and prevents complete blockage.

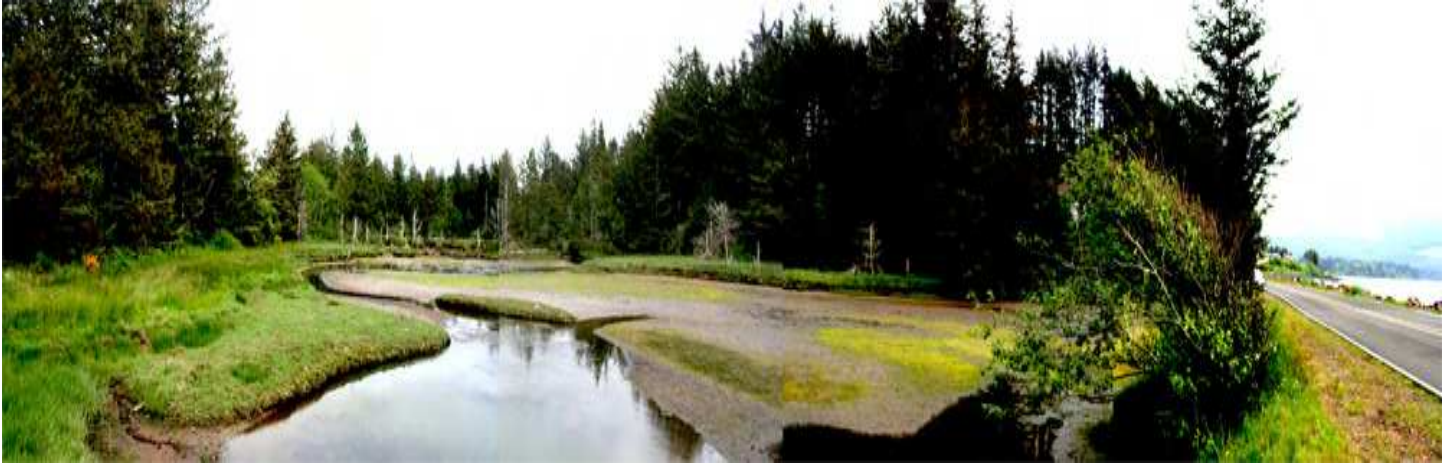
Lower Northbay Creek is a severely altered stream channel. The mouth is fairly brushy up to a large dam that impounds several hundred meters of creek to create a recreational pond. Beyond this pond the creek becomes brushy up to timber land where flow stops. Access was denied for the majority of the stream channel and surveys of this reach were conducted from a public road.

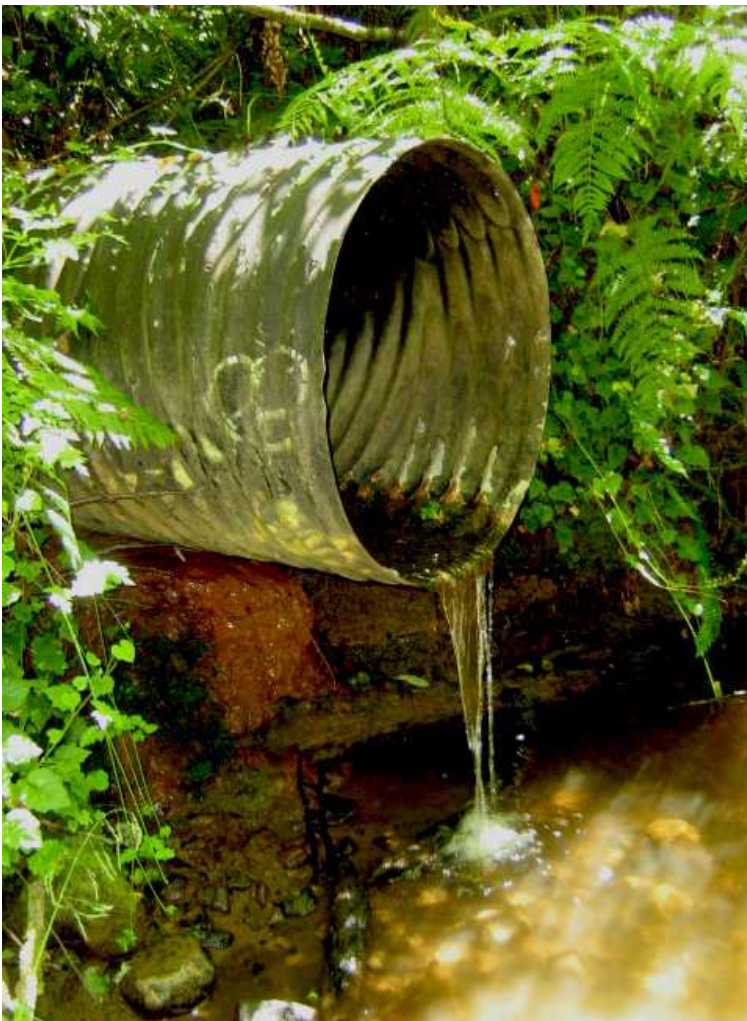
Two culverts may block fish passage (see photograph on left). Additionally, Rice is prone to bank failure and slumping. Road maintenance and construction should take this into special consideration.

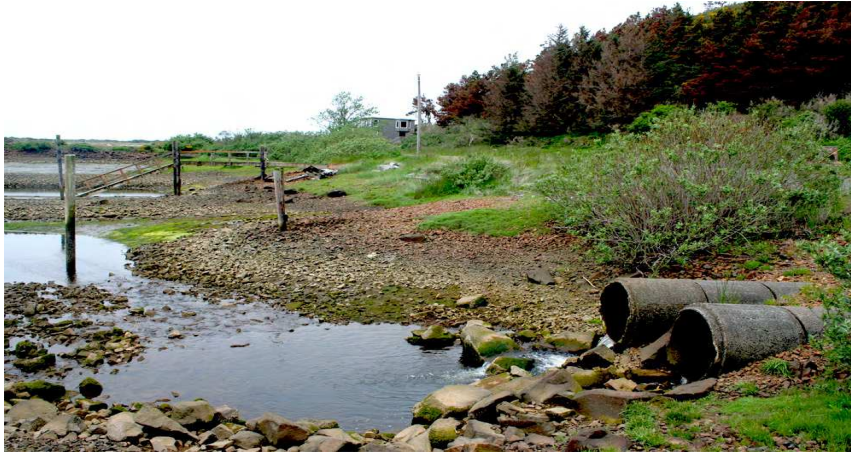
Although poorly placed and failing (see photograph above), the culvert at the boat launch is passable to adult salmonid (possibly not Chum) and spawning does occur upstream. Likewise, two small waterfalls on private non-industrial land and the first culvert past these cascades are also passable to adult salmon despite the fact that water is flowing under rather than through the culvert. These are all however barriers to juvenile salmon seeking cooler waters and deeper pools upstream. The first road crossing on land managed for timber appears to have a planned replacement with larger culverts staged along the roadside adjacent to the culvert. The construction staging and road use (maybe road grading to some extent) also appears to be delivering some fine sediments immediately downstream.

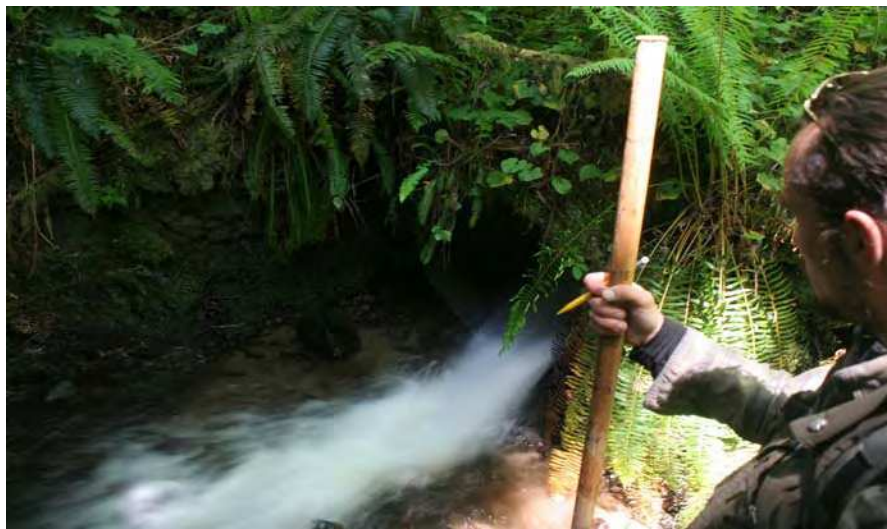
Although neither of the first two culverts on the mainstem of Fall Creek are definitive barriers to passage as spawning occurred upstream of both, the first culvert is a juvenile salmonid barrier with a drop of ~10 cm and the second is an extreme adult deterrent and juvenile barrier. The first culvert is undersized at 1.2 meters X 1.5 meters and bankful widths above and below 2 m and 3 meters respectively. The concrete substrate of the culvert does not appear to accumulate fine sediments or gravels. The ~30 m culvert is relatively flat on the channel bottom but surveyors noted a depression in the middle which may indicate future failure; the culvert appears to be sinking slightly. The second culvert is extremely undersized and is failing (refer to photograph below - water seeping around and beneath the culvert). Were this culvert to fail the resultant debris would not pass through the downstream culvert possibly reducing the integrity of the road. The North Fork Fall Creek confluence is directly upstream of the second culvert where the valley widens and Fall Creek becomes much more connected to its floodplain. The first culvert on the North Fork of Fall Creek is failing; the mouth is crushed nearly shut.

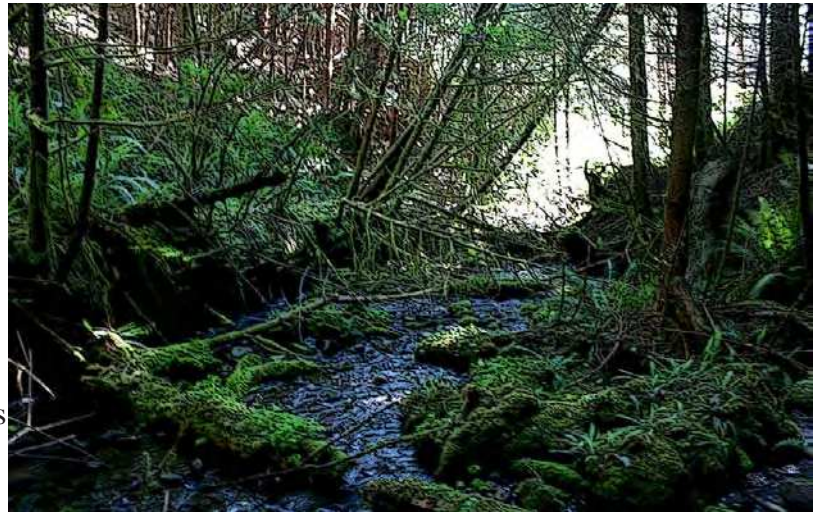
Nearly the entire length of Fall Creek has been identified as containing high risk hill-slopes. This was verified during field surveys with high wood volumes and copious gravels.

Downstream land-use is mixed; the beach at the mouth of Fall Creek is public, upstream portions are mixed private non-industrial and private industrial with a water withdraw on the North Fork for Netarts municipal water.
